# MEMO

**Subject:** LTV Steel Site Visit Report - February 23, 2000

**Photograph Log from 23, 2000  
Site Visit**

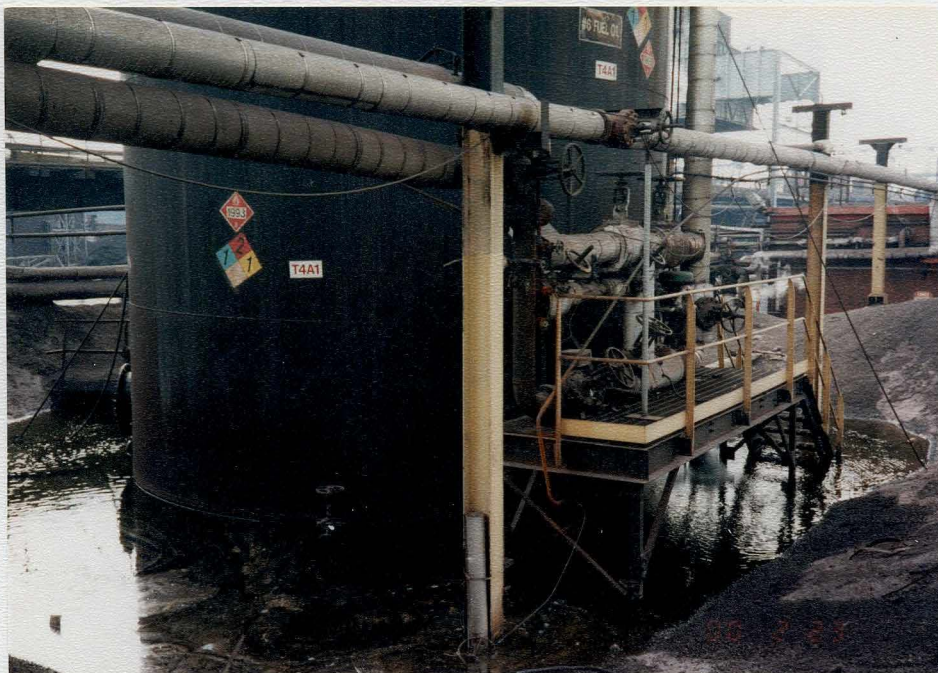
Photo No.: R1P1  
Direction: Southeast

Description: View of the Former Cadence Tank Area (SWMU 35) which is currently an above ground storage tank (AST) containing Fuel Oil #6. The photo was taken from directly on top of the bermed area surrounding the AST. Note the water pooled around the bottom of the AST and the sheen on the surface of the water.

view of the fuel oil # 6 tank. Note  
water and sheen floating on water.  
Picture from atop of berm.

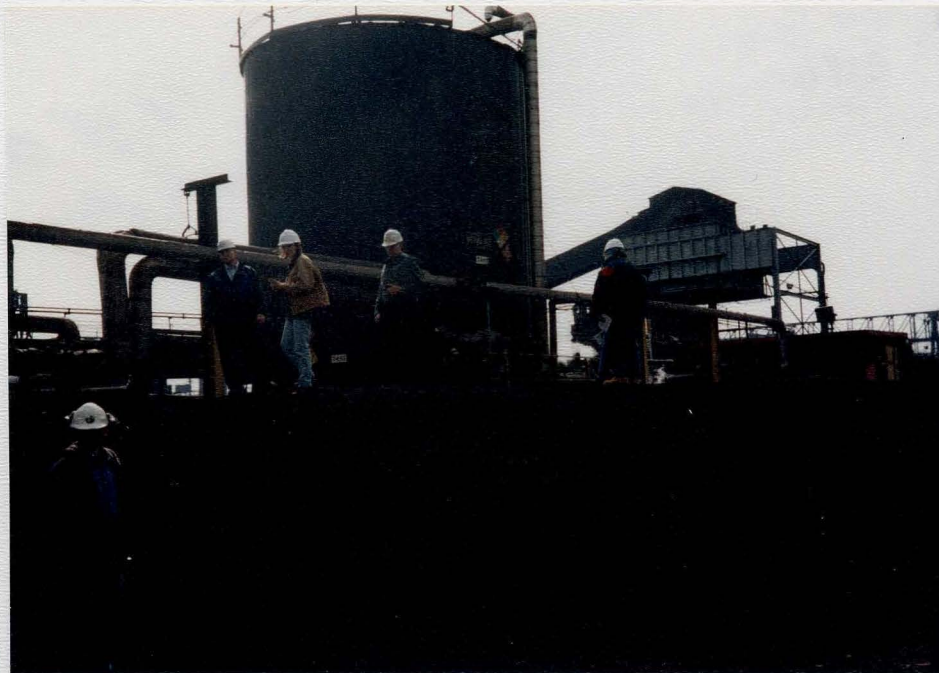
Photo No.: R1P2  
Direction: Southeast

Description: View of the AST containing Fuel Oil #6, which is located at the Former Cadence Tank Area (SWMU 35). This photo was taken from the bottom of the bermed area, looking upward.

Photo of the #6 fuel oil tank  
from bottom of berm looking  
up.

water was all around the bottom  
of the tank. Sheen floating  
on top.

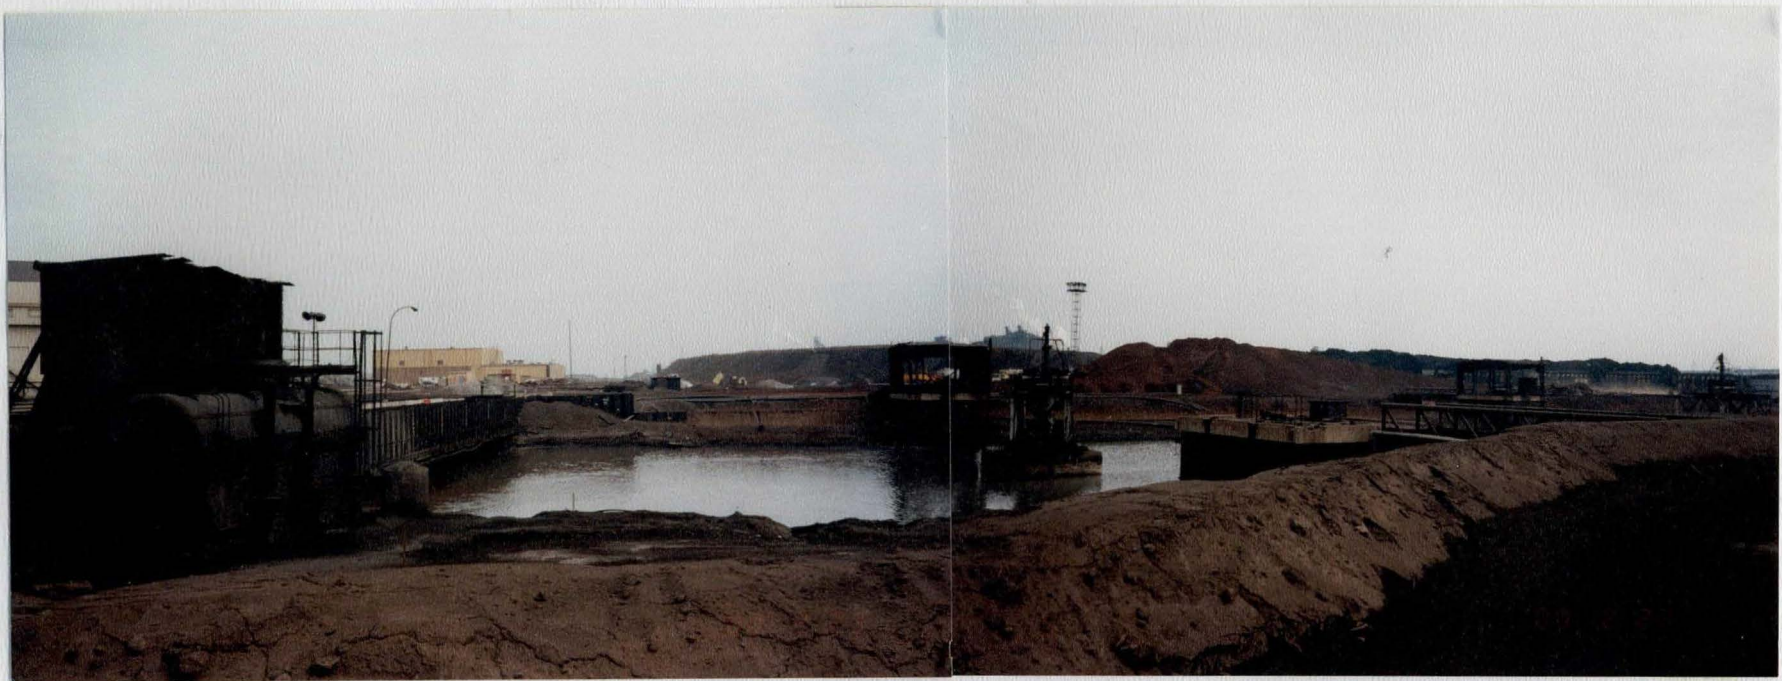
Photo No.: R1P3 - R1P4  
Direction: North - Northeast

Description: Panoramic view of the Terminal Lagoon Area (SWMU 10). A scale pit exists near the lagoon area. Water from the steel plant flows through the scale pit and is then processed at this SWMU. Note in the background of the photo the large pile of Basic Oxygen Furnace (BOF) dust transported here from the BOF.

view of the Terminal Lagoon (SWMU 10)

there is a scale pit ahead of the  
Terminal Lagoon which has the  
major water flow from the  
steel plant + then processed through  
this system.

In photo RIP3 - RIP4 - note the  
Basic Oxygen Furnace (BOF)  
dust.

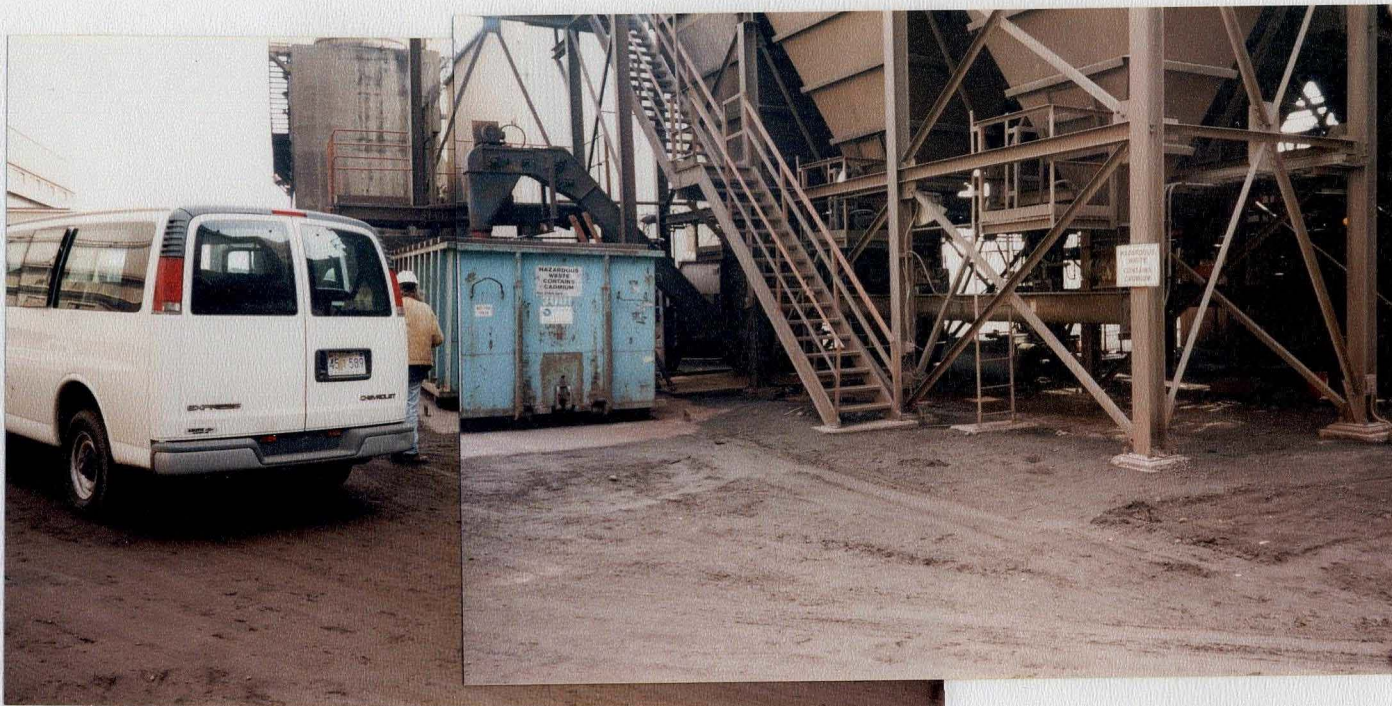
Photo No.: R1P5 - R1P6  
Direction: Southeast

Description: Panoramic view of the Ladle Metallurgy Facility Baghouse (SWMU 11) and the roll off box containing hazardous cadmium waste. There is a concrete pad underlying the roll off box, but there does not appear to be any containment located underneath the Baghouse. Note the fill start date on the hazardous waste roll off is labeled 2-18-00.

view of the LMF Baghouse and the  
roll off containing hazardous waste  
cadmium.

Note on photo RIP5 the fill start date  
on the haz. waste roll off is  
2-18-00.

Concrete underneath roll off box -  
does not appear to be any concrete or  
containment under baghouse.

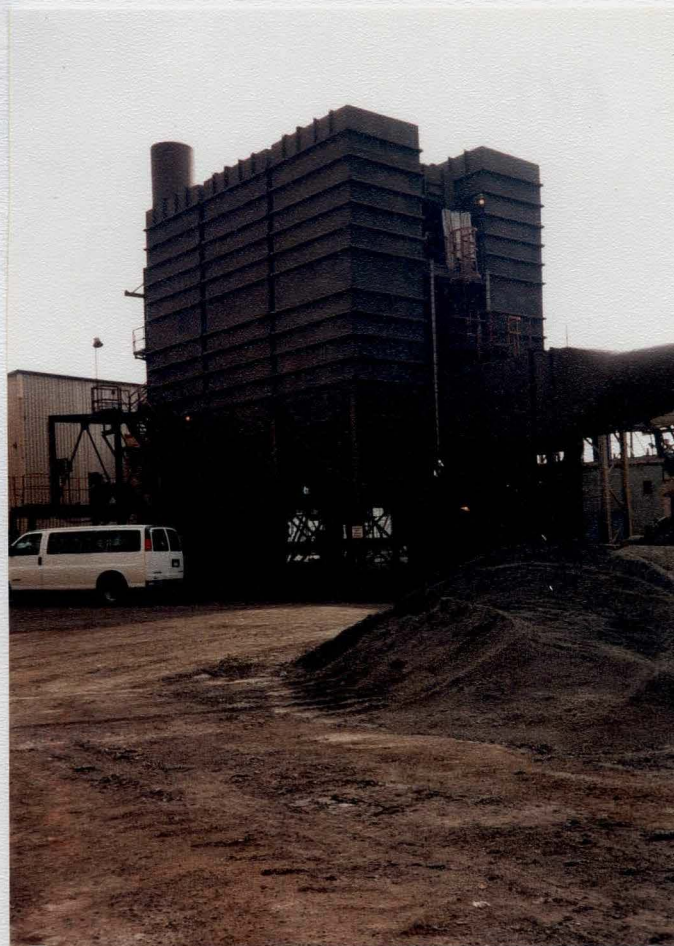
Photo No: R1P7  
Direction: Southeast

Description: Full length photograph of the Ladle Metallurgy Facility Baghouse (SWMU 11).  
Hazardous cadmium waste roll off box is obscured by van on side of Baghouse.

view of baghouse & containment  
for waste cadmium.

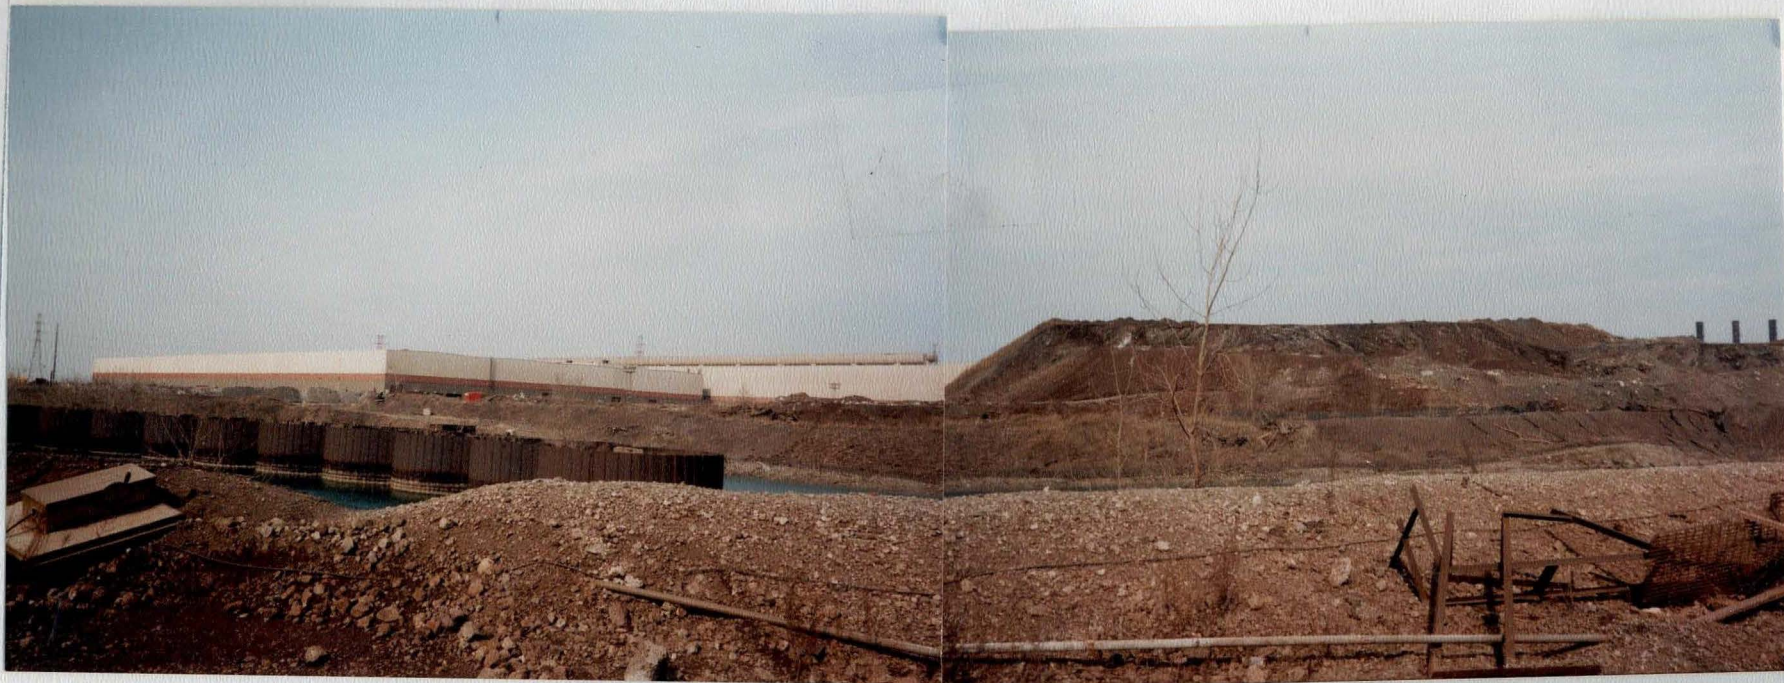
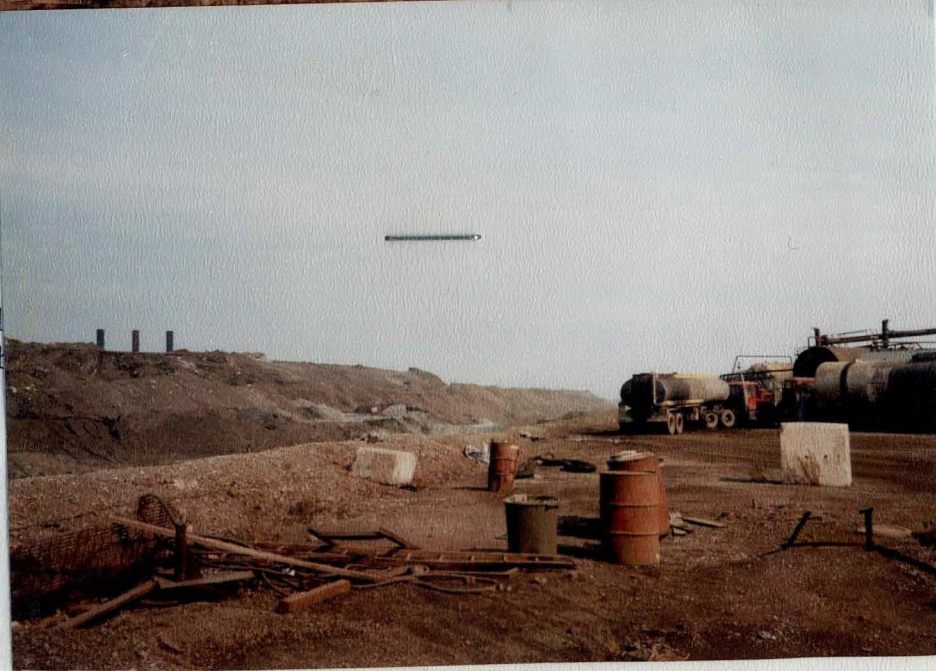
Photo No.: R1P8 - R1P10  
 Direction: North - Northeast

Description: Panoramic view of the Clark Landfill  
 empty but bulged out on the top and b

<sup>DSC</sup>  
view panoramic view of the Clark landfill.

Photo RIP10 - note drums & scrap materials  
in the foreground.

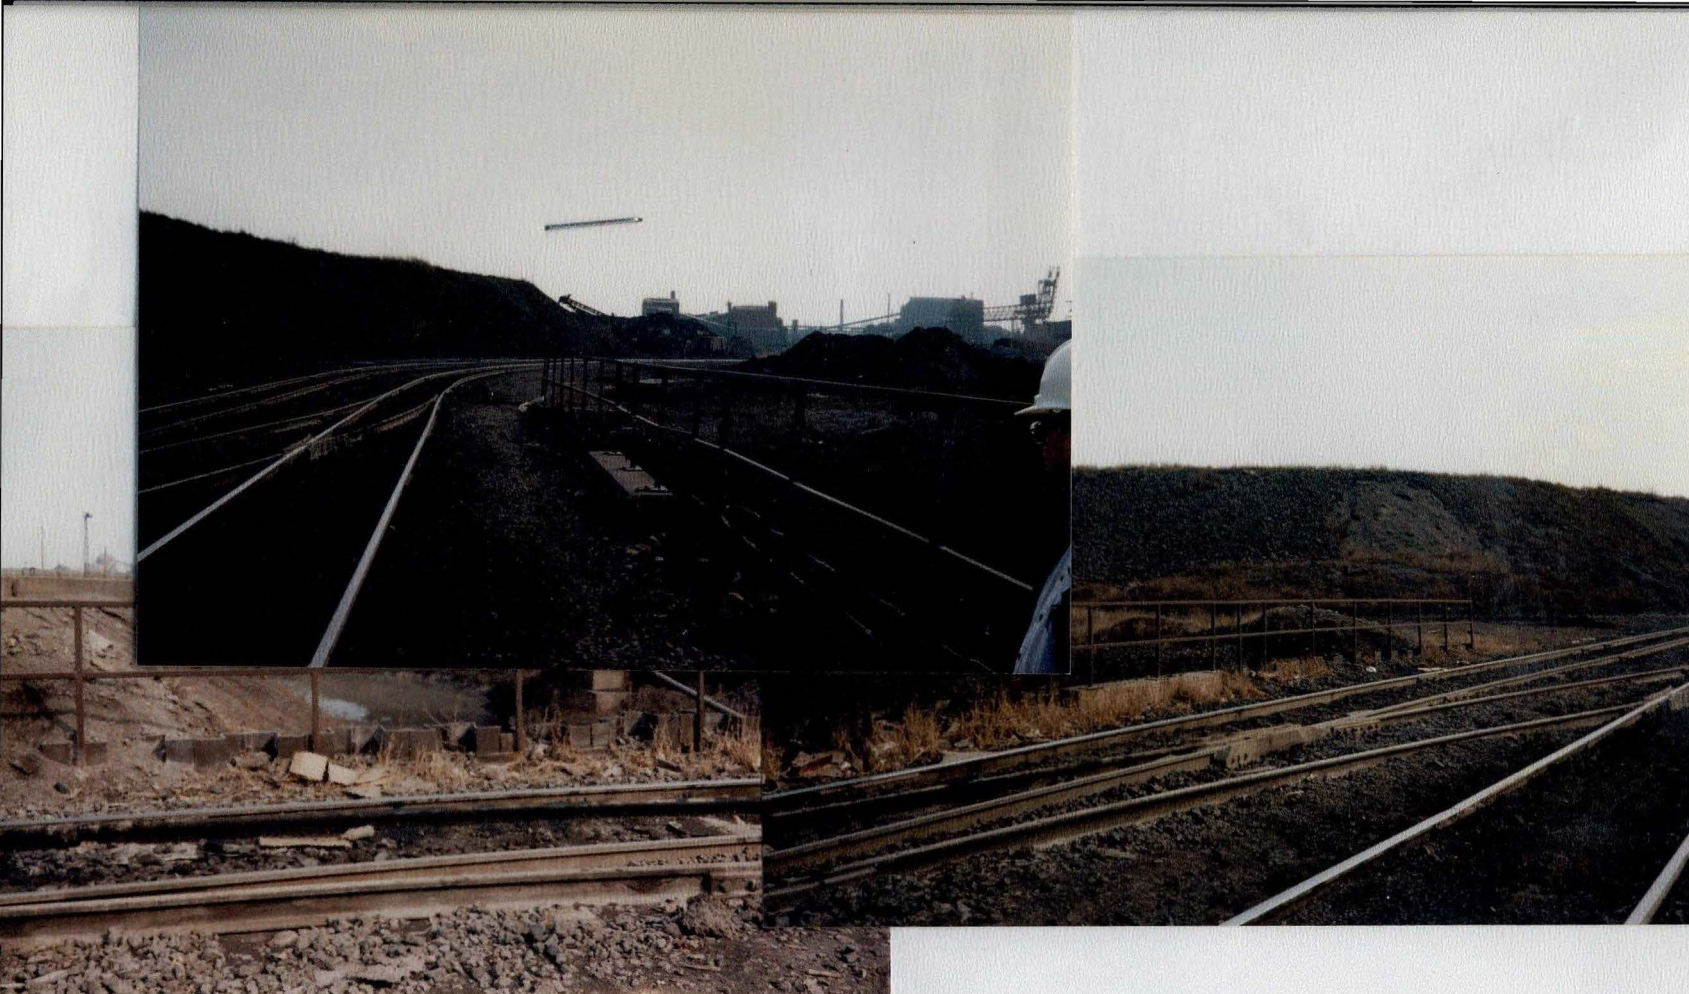
Photo No.: R1P11 - R1P13  
Direction: North - Northeast

Description: View of SWMU 7, "The Hill". "The Hill" was stated to be used as a landfill for steel mill wastes, although LTV persons disposed of at this landfill. This SWMU is no longer in operation. Note on the left side of the photo the ditch containing treatment plant.

view of "the Hill" - note the scrub  
grass on "the Hill"

Note in RIP11 the wastewater running to the wastewater treatment plant.

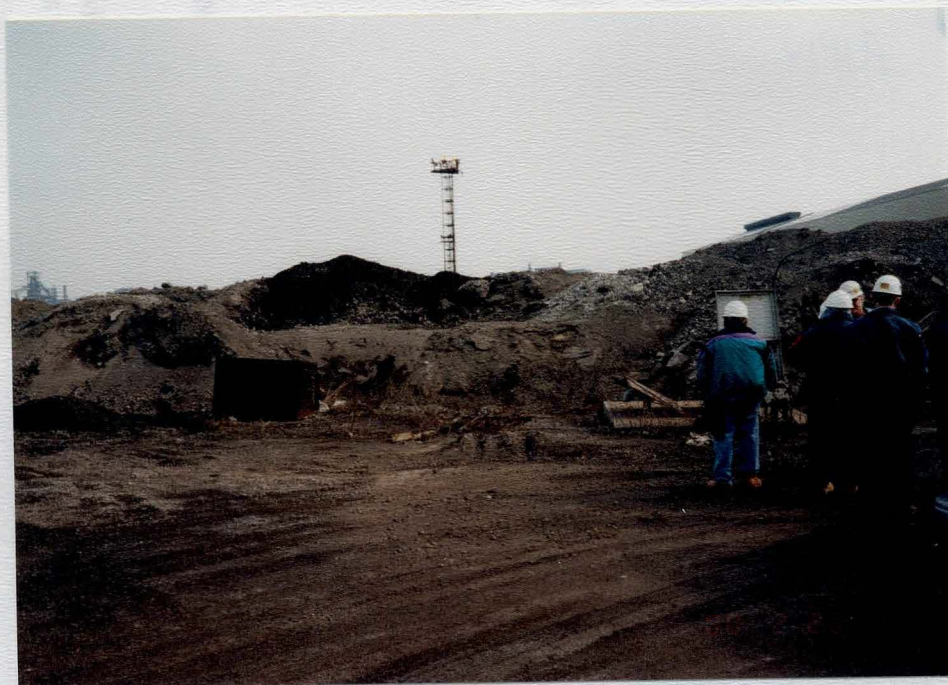
Photo No.: R1P14  
Direction: Southeast

Description: Photo of the former Concrete Sludge Drying Beds (SWMU 27). A concrete wall used to surround the beds, and reportedly contained the sludge. It is unclear if there was a concrete floor under the drying beds. The concrete wall no longer exists and the area of the SWMU is now covered with piles of debris.

view of former concrete sludge drying beds (SWMU 27). The concrete wall no longer exists and debris now covered on top of drying beds.

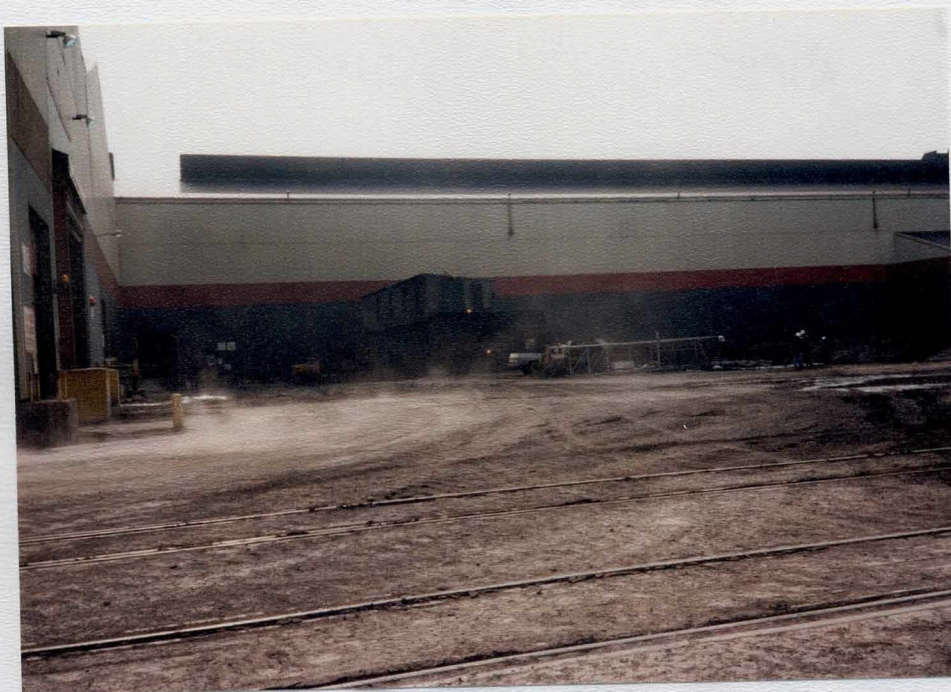
Photo No.: R1P15  
Direction: Southwest

Description: Photograph of the area where the Filter Backwash Pile (SWMU 23) formerly existed. The location of this SWMU is in the area near the pickup truck in the photo (center of photo). This pile no longer exists and now is a concrete-lined pit.

view of SWMU 23's former location near blue pick up truck.

Note: a concrete lined pit now exists where SWMU 23 was located

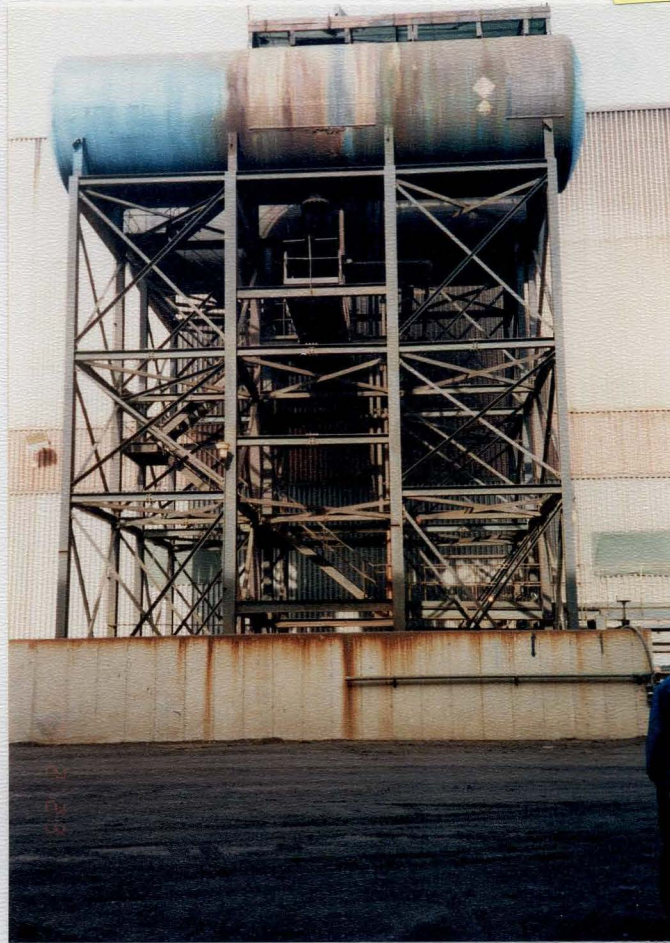
Photo No.: R1P16  
Direction: North

Description: View of the Spent Pickle Liquor Tanks (SWMU 28 and 29). Note the staining on the concrete wall which may be considered as secondary containment.

view of the spent pickle liquor tanks (swmu 28+29). Note the staining on the concrete <sup>berm</sup> which may possibly be considered secondary containment.

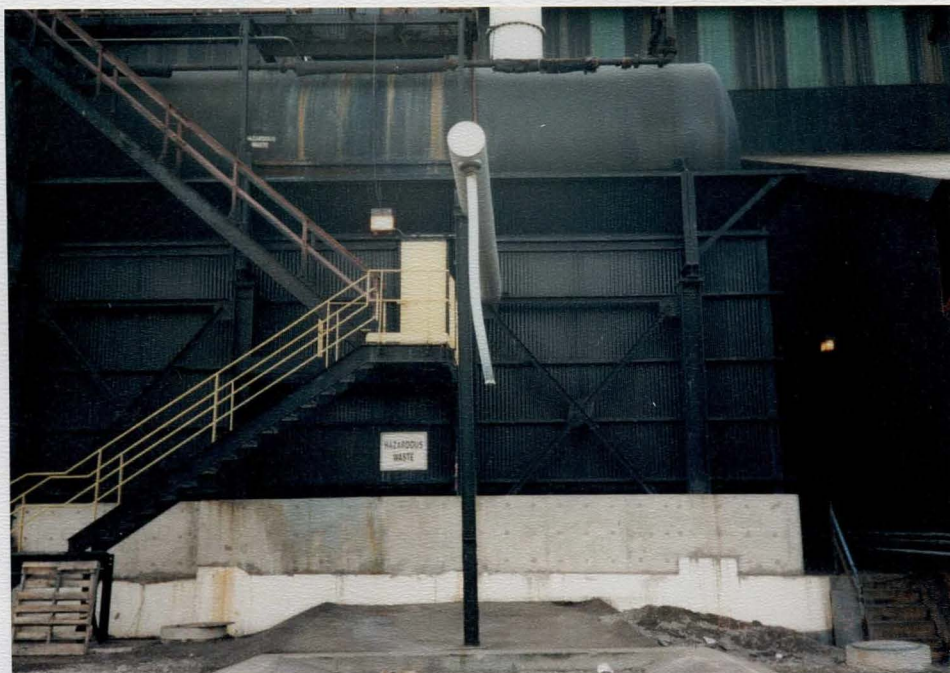
Photo No.: R1P19  
Direction: South

Description: View of the Waste Tin Line Washwater Tank (SWMU 44). Note the metal structure beneath the tank is labeled "Hazardous Waste".

#2 Waste Chromic Acid Tank  
Area (former SWMU 50).  
Now concrete catch basin  
in area.

↳ picture is actually SWMU 44.

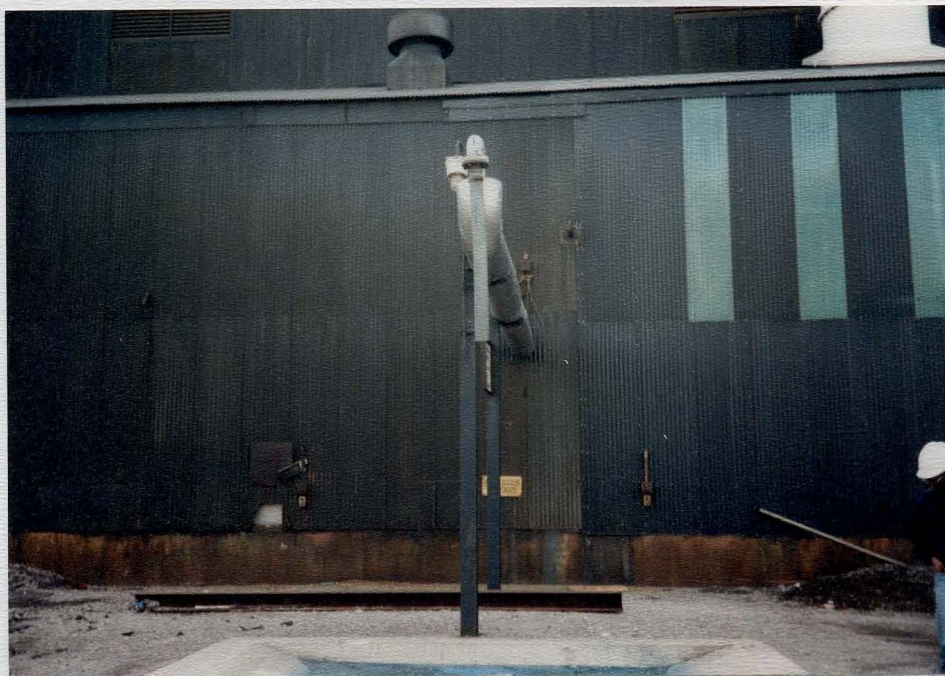
Photo No.: R1P20  
Direction: South

Also, visible blue staining was noted on the ground at the No. 2 Tin Mill Waste Sodium Dichromate Truck Loading Station (SWMU 45). It was stated by Mr. Alan Cross of LTV that a blue dye is added to the waste managed at SWMU 45. However, for the purpose of future reference it should be determined when the dye is added to the waste stream. If the dye is added before the waste sodium dichromate is pumped into the trucks, the visible staining around the ground surface could be an indication of contamination since the "blue areas" could contain waste sodium dichromate.

Description: View of the No. 2 Tin Mill Waste Sodium Dichromate Truck Loading Station (SWMU 45). Note the blue staining in the bottom of the loading basin. Also, there were several areas on the gravel surrounding the loading basin that had blue staining.

view of the waste sodium dichromate  
loading area (SWMU 45).  
note the blue staining in  
basin and building bottom. Also  
note the blue around the  
outside of basin.

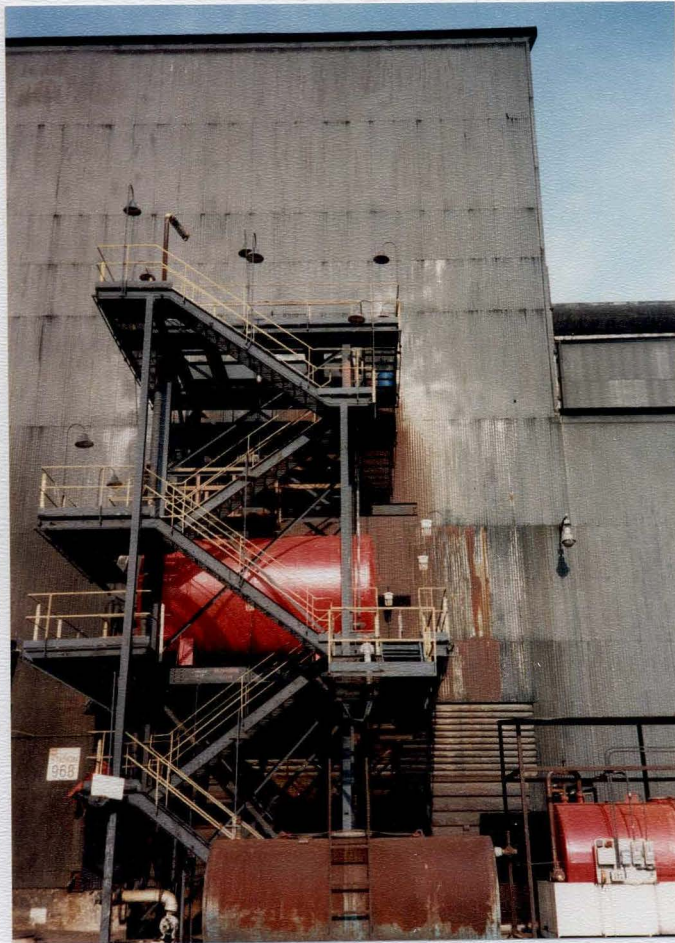
Photo No.: R1P21  
Direction: East

Description: Photograph of the No. 2 Tin Mill Waste Chromic Acid Tank (SWMU 50) located on the middle level of the scaffolding. In the photos from the 1992 RCRA Facility Assessment Report, a second tank was previously located on the upper level of the scaffolding. Note the staining/rust on the building.

view of the chromic acid (SWMU 50)  
tank on 2nd level. Note  
the rust on the building  
and the absence of a tank  
on the top level - present  
in RFA -

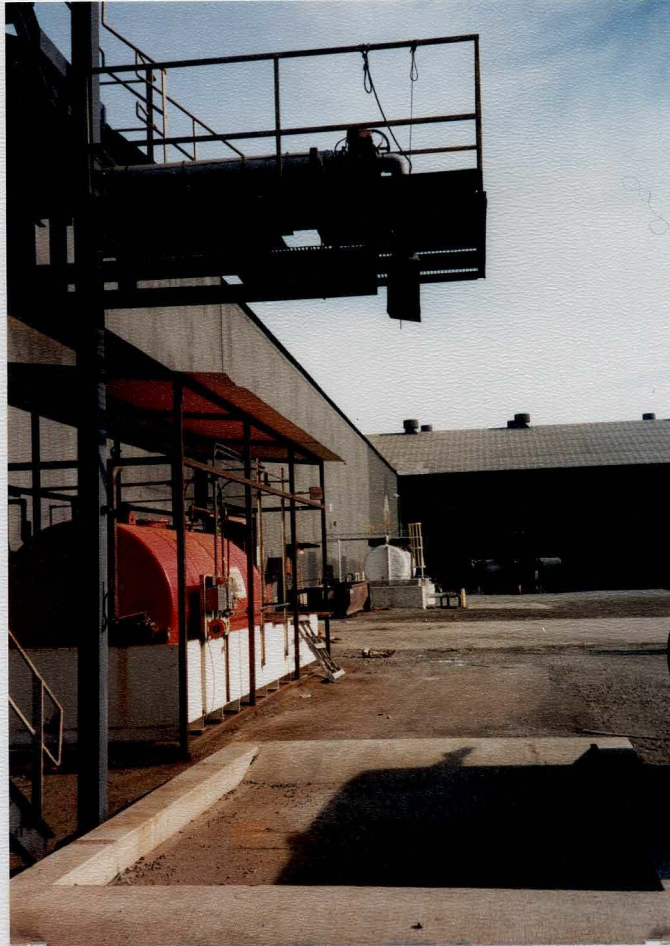
Photo No.: R1P22  
Direction: Northeast

Description: View of the truck wash station at the No. 2. Tin Mill Waste Chromic Acid Station (SWMU 50). New concrete and gravel appear to have recently been placed in this area.

view of truck wash station at  
SWMU 50. Note the new concrete  
and gravel in area.

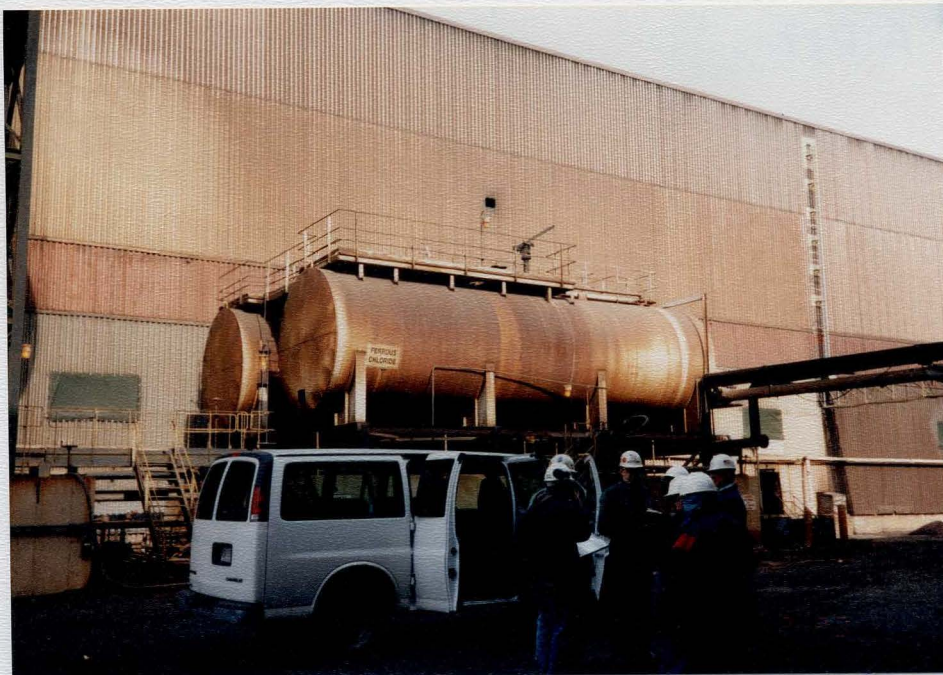
Photo No.: R1P17  
Direction: Northeast

Description: Photograph of the ferrous chloride waste tanks. The tanks appear to be labeled as hazardous. Note the staining on the concrete berm around the tanks.

view of the ferrous chloride (waste) tanks & the staining on the concrete berm. These tanks are labeled as hazardous.

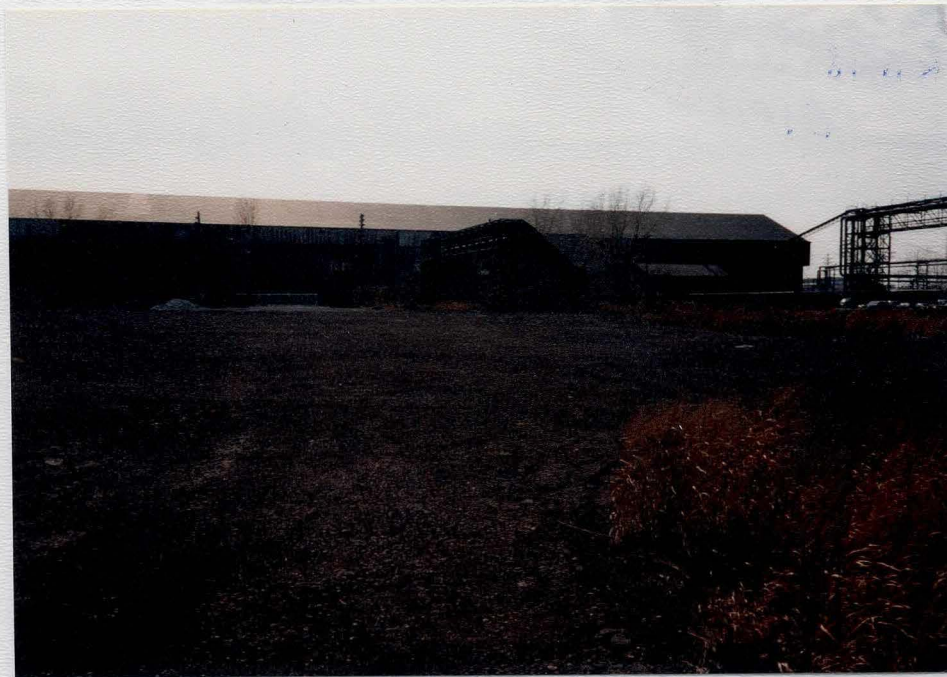
Photo No.: R1P18  
Direction: Southwest

Description: Photo of the former Coke Plant Decanter Site (SWMU 65). The coke manufacturing operations at the site no longer exist. The area is now covered with scrub brush and the majority of buildings have been demolished in this area.

View of the former swmu 65 - Area is now scrub brush & all coke plant buildings (decanter) are removed from this area.
